**RE: Roosevelt High School  
 540 Eureka, Wyandotte, MI 48192**

**Overview**

# Laboratory Report

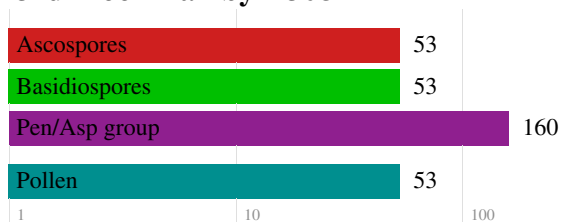
#### 3rd Floor Hall by A308

Sample Identification	Raw Count	Spores/cu. m	Percent(%)
- Fungi -			
Pen/Asp group	3	160	60.15%
Ascospores	1	53	19.92%
Basidiospores	1	53	19.92%
Total Fungi	5	266	100.00%
- Other -			
Pollen	1	53	100.00%
